TWA Flight 800 Missile Impact Analysis

by
Richard Bott
Survivability Division
Systems Engineering Department

DECEMBER 1997

NAWCWPNS TM 8126

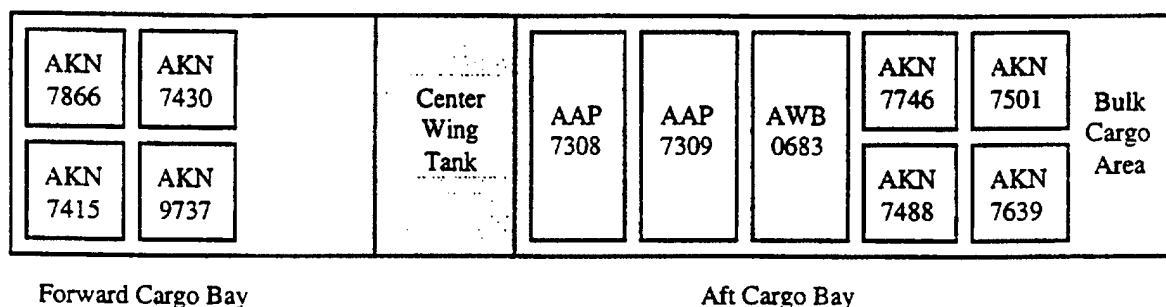
FIGURE 1. Cargo Container Locations on TWA Flight 800.

Four baggage containers were located in the forward cargo compartment of TWA Flight 800. A diagram of all container locations is shown in Figure 1. The two containers on the left side of the aircraft, AKN7415 and AKN9737, were recovered in the red debris field and were not severely damaged. Both containers have virtually all sides intact, and the damage is consistent with water impact.

The two containers on the right side of the forward cargo hold, AKN7866 and AKN7430, were recovered in the yellow debris field. These containers are more severely damaged, but the majority have been recovered and reconstructed. The damage also appears to be attributable to water impact.

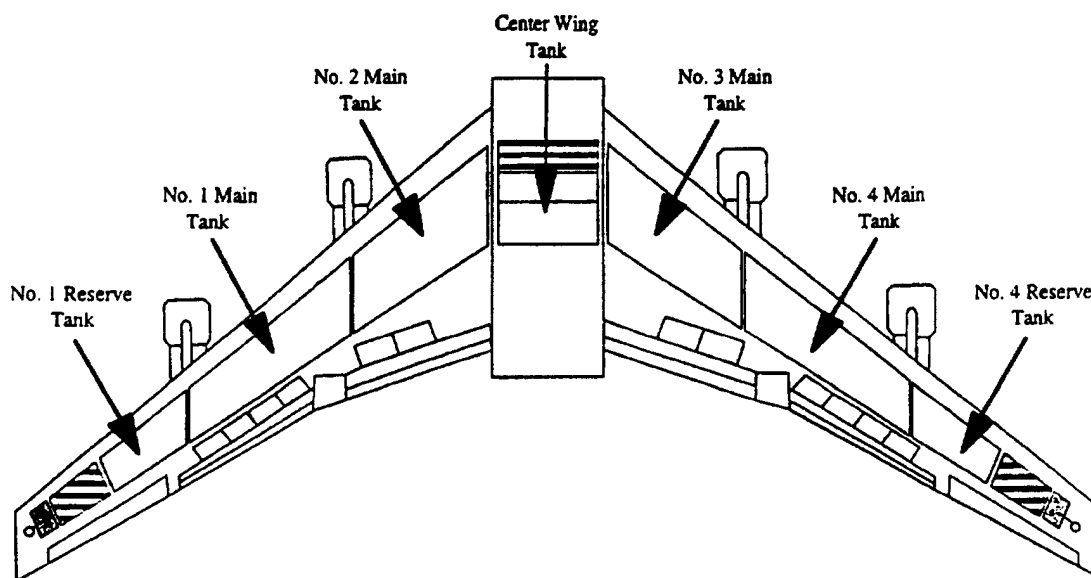
FIGURE 2. Boeing 747-100 Fuel Tank Arrangement.

The thickest part of the wing fuel tanks are at the fuselage where the number 2 and number 3 main tanks butt up against the center wing tank. A schematic of the 747 wing fuel

tanks is shown in Figure 2. The kinetic energy of the missile body and the explosive energy of the detonating warhead would create a significant hydrodynamic ram event that could cause severe damage to one or more of the following structures even though the possibility exists that warhead fragmentation damage would not occur:

1. Upper/lower wing skins
2. Wing spar webs
3. Side-of-body ribs separating the center wing tank from the adjacent main wing tanks
4. Wing leading-edge fairing

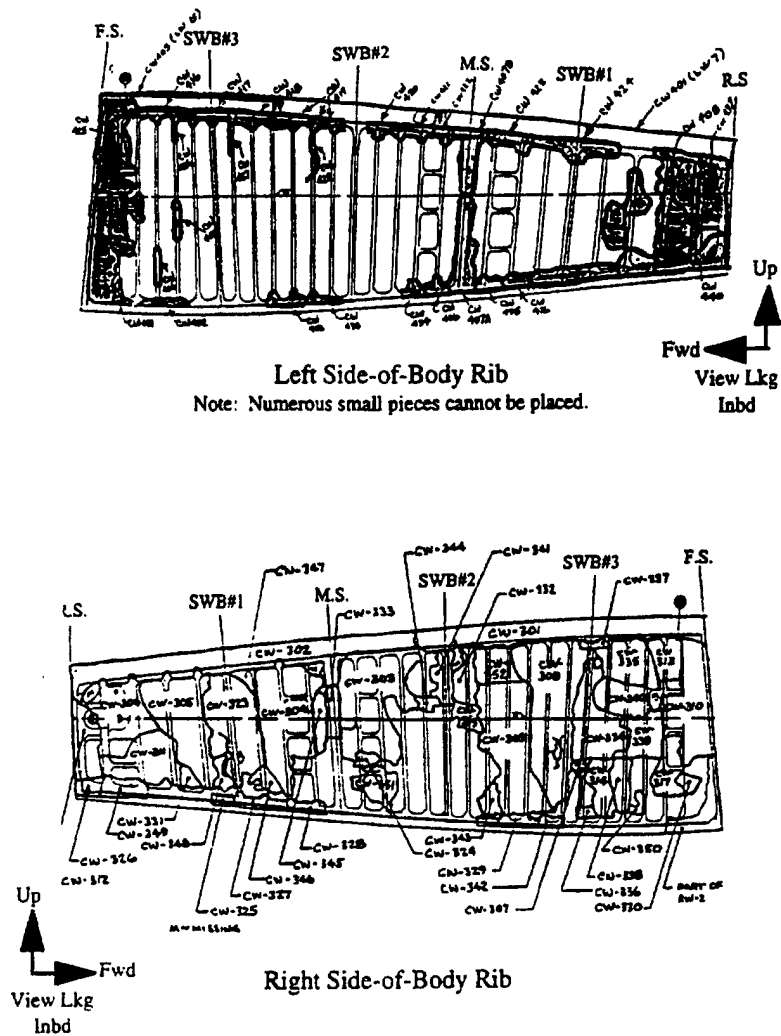
FIGURE 4. TWA Flight 800 Side-of-Body Rib Damage.

Detailed examinations of the TWA Flight 800 wing fuel tanks were conducted. The left upper wing skin, the left side-of-body rib, and the left leading-edge spar exhibit different and more severe damage from their right wing counterparts. Figures 3, 4, and 5 show comparisons of the damage to the upper wing skins, side-of-body ribs, and inboard leading-edge spars, respectively. Close inspections of the wreckage in these areas revealed no evidence of penetrations by foreign objects and no high-velocity fragment damage consistent with a missile impact. NTSB and FBI documentation support these findings (References 3 and 4).

Conceivably, a missile impact in the wing-root fuel tank area could create enough damage to cause the side-of-body rib to collapse into the center wing tank. This collapse could occur without significant release of material from the wing structure, but the preponderance of evidence suggests this did not occur on TWA Flight 800. Most compelling is the fact that both wings remained with the aft fuselage section until they were well downrange. If the severe left wing damage had been caused by a missile impact, the expected result would be an early release of that wing, or at least numerous pieces of it, well uprange in the red recovery zone.
